HAZARDOUS MATERIALS SURVEY REPORT

**Former Rainier Brewery and
Warehouse
3100 Airport Way
Seattle, Washington 98134**

July 27, 2006

VEI Project #060628 HAZMAT Survey

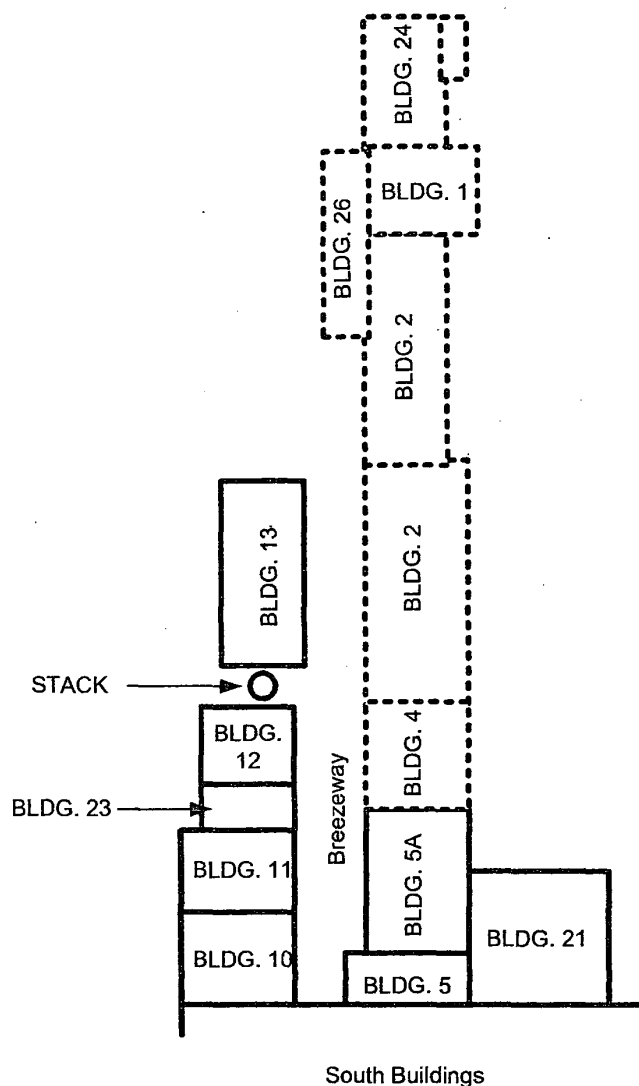
FIGURE 1

5/5A – lights, ballasts, plaster, CFCs, elect.
10 – lights, ballasts, plaster
11 – lights, ballasts, plaster
12 – lights, ballasts, plaster
13 – lights, ballasts, plaster, CFCs
21 – foam, lights, ballasts, plaster
23 – lights, ballasts, plaster
Stack - none

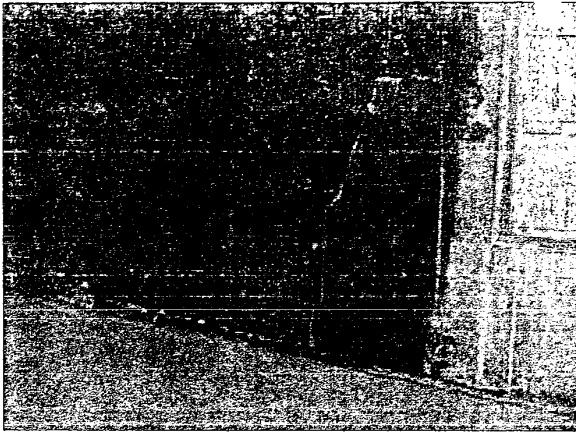
- Black foam wall and ceiling insulation in Buildings 21 and 25.

7. Foam wall insulation – Building 25

- The owner should complete any applicable notification forms and permits needed to renovate or demolish a structure in Seattle, King County, Washington.
- Conduct TCLP sampling on other materials (wall cork, plaster walls, and firebrick) prior to disposal to document compliance with RCRA.
- Test the wall foam for flammability, due to the presence of organic odors noticed upon sampling.

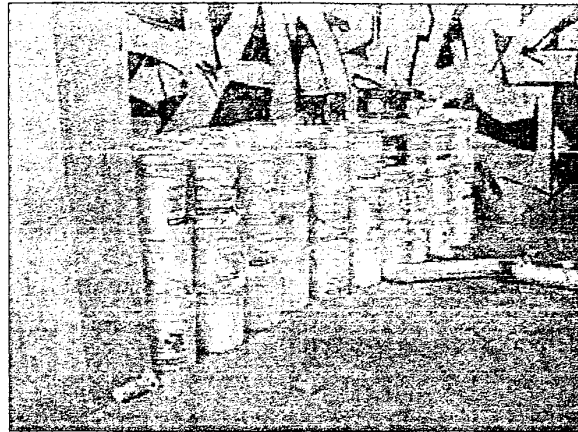
- Approximately 100 gallons of latex paint in Building 18.
- Elevator and lubrication fluids in Building 25.

8. Paints in Building 18

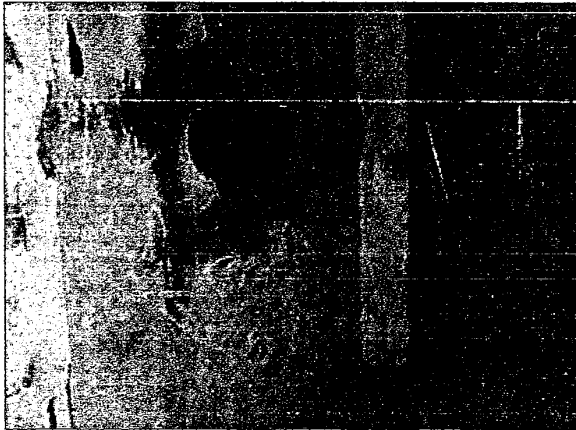
9. Cork wall insulation

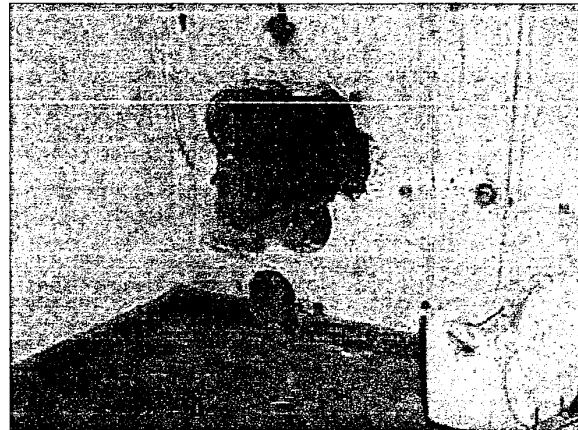
- Interior paint on plaster, containing 3,600 ppm PCBs in all buildings.
- Light ballasts in the fluorescent lights (presumed) in Buildings 5/5A, 6 (east side only), 7, 10, 11, 12, 13, 14, 15, 18, 21/22, 23, and 25.
- Elevator / electrical equipment in Building 5/5A and 25.

10. Plaster walls – Building 5A

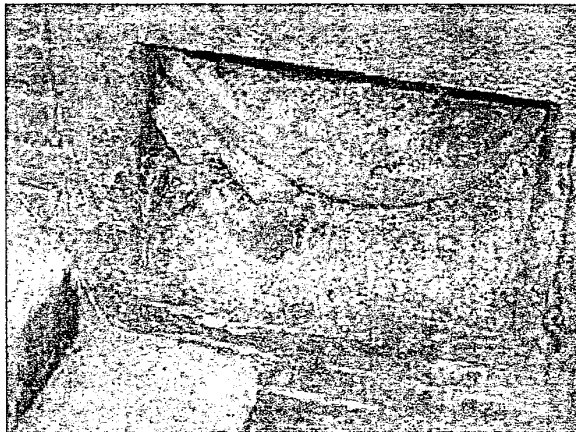
11. Firebrick in Stack

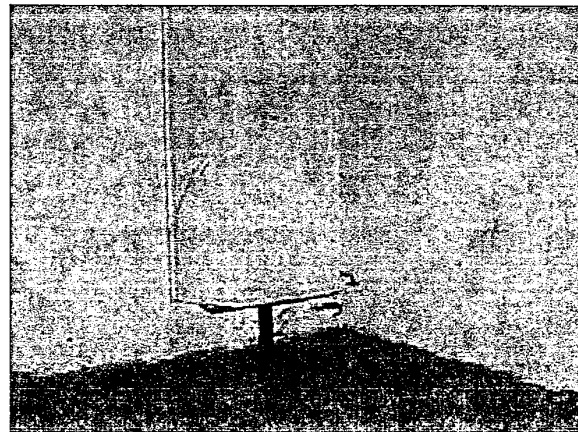
- Coolant in Cellar F of Building 5A.
- Coolant in mechanical system of Building 13.

12. CFCs – Building 5A – Cellar F, level 300

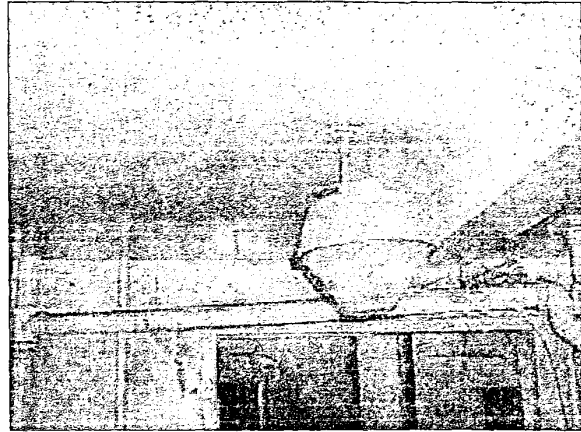
- There are suspect mercury-containing light bulbs located in each building at the Former Rainier Brewery.

2. Florescent lights and bulbs

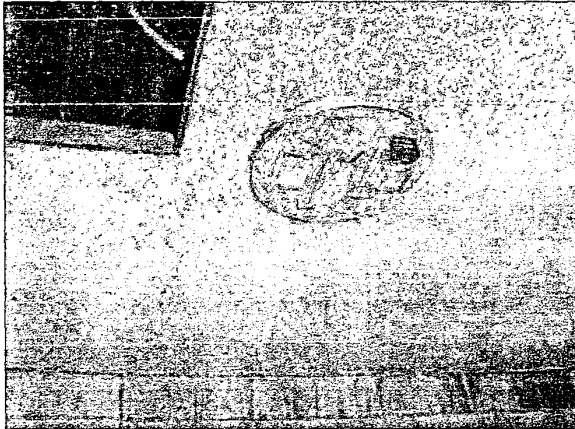
3. Fluorescent lights and ballasts – Building 25

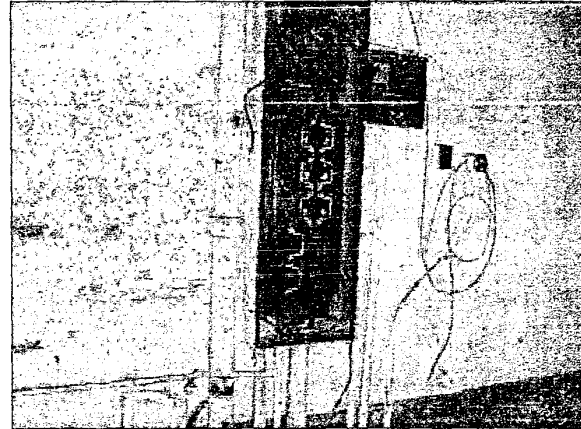
4. Suspect PCB electrical equipment – Building 5A

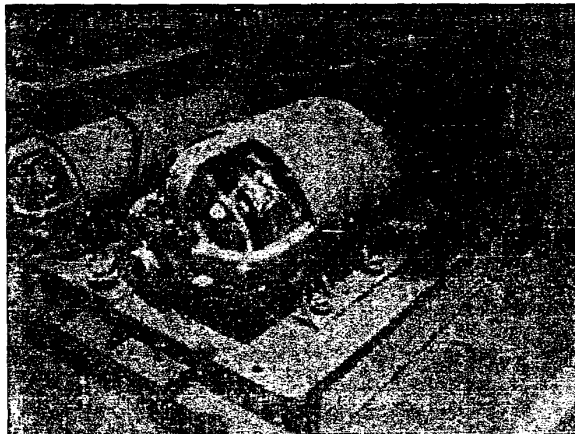
5. Elevator equipment – Building 25 – level 800

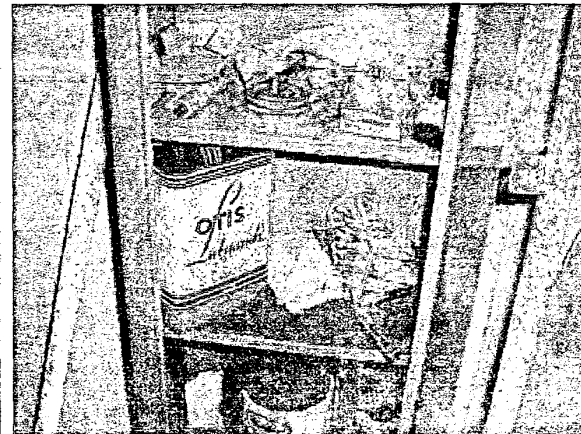
6. Lubrication fluid – Building 25 – level 800
